Quinquennial Inspection

**St Stephen's Church
Station Road
Borrowash, Derby**

July 2013

St Stephen's Church Quinquennial Inspection Report

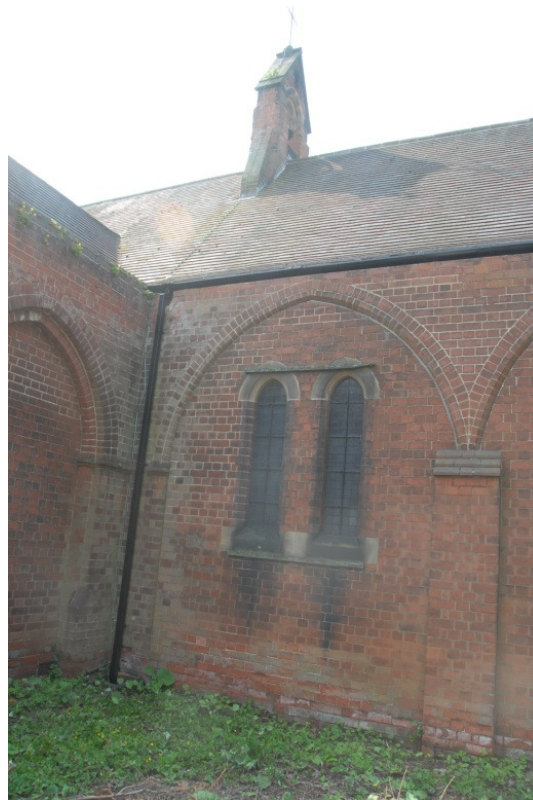
026 West Side of Organ Chamber

There are two brick parapets, one on the SW. The west face of the organ chamber has a concrete parapet which is cracked in the centre and needs replacing.

This side of the organ chamber will need checking under the lead gutter for leaks at the same time (see photograph 026).

| a) | Scaffold and replace/repair concrete parapet to organ oft west elevation. | £1,000 |

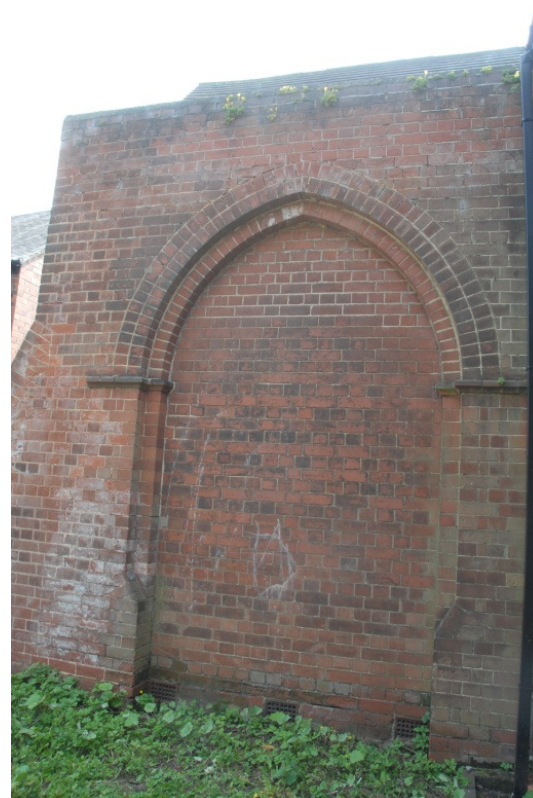
027 North Side of Chapel

All the external walls consist of a red clay facing brick with fine mortar joints. The bricks are laid in Flemish bond. The overall condition of bricks and pointing is mixed. There is a large variation of recently pointed brickwork, staining, graffiti and plant growth (see photograph 027).

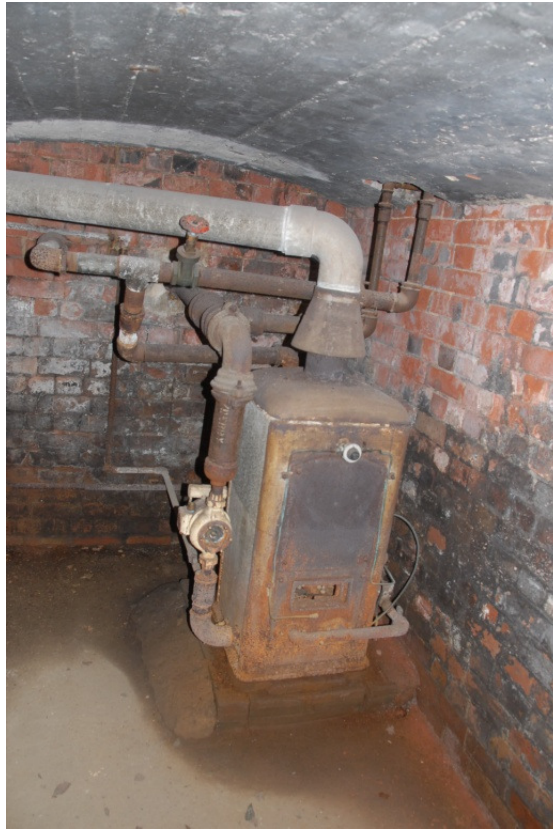
048 Basement and Redundant boiler

The basement is now only used for incoming electrics and has a redundant boiler/flue (see photograph 048). There is loose render on the adjoining wall to the steps. The internal walls are brickwork.

It would be prudent to arrange for testing to the asbestos and removal of same to avoid any risk to future occupants.

It would be prudent to dispose of the asbestos flue before it becomes a hazard as it is a legal requirement to notify of its risk/existence.

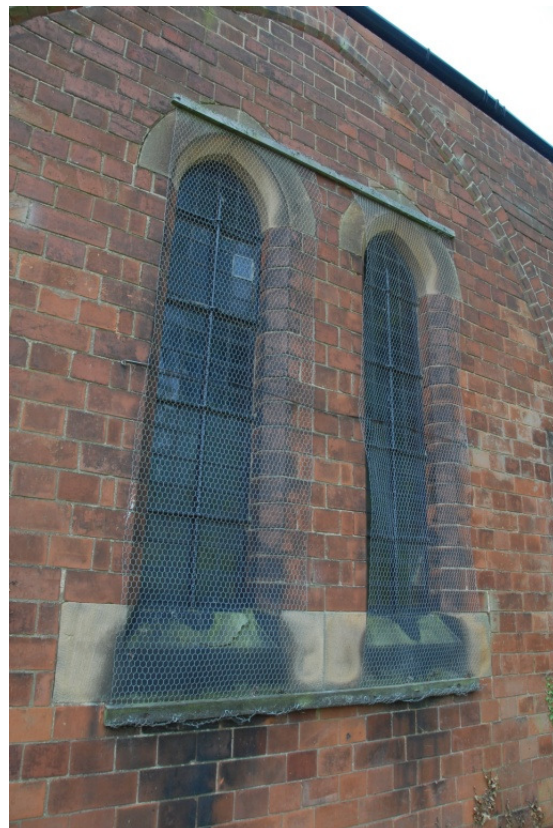
030 Typical Window (North Side of Nave)

The brick walls have stone heads and cills around the windows but the appearance is spoilt by bird mesh spread over the windows and blackened by rust staining (see photograph 030).

| c) | Remove rusting galvanised mesh from remainder of external windows, de-rust and paint metal saddlebars. Fit new stainless steel powder coated guards to existing joints with matching screws. Clean staining off stone cills. | £10,000 |

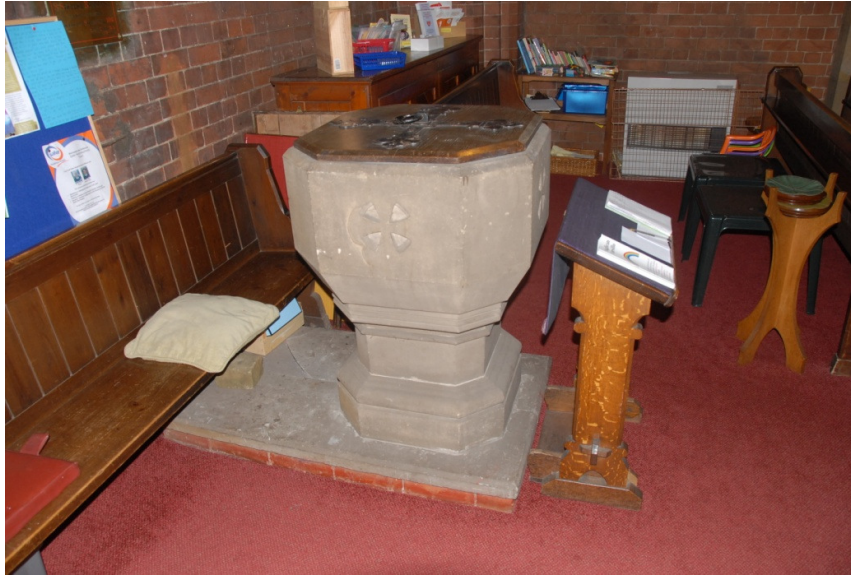
065 Font (West End)

the church (see photograph 065). There are nine rows of pine pews with one loose pew at the rear.

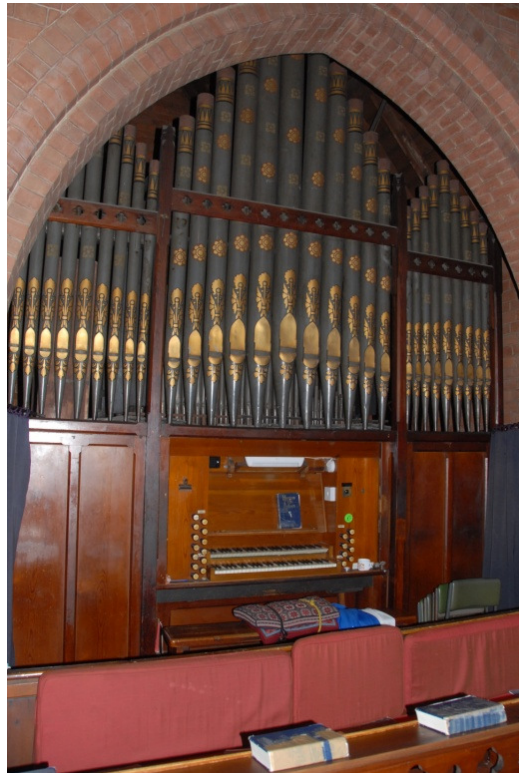
075 – Organ

The pipe organ had a major overhaul in 1990 and is tuned regularly by Groves of Nottingham who was the original builder. I would recommend that a detailed investigation and quotation be obtained from Groves or similar specialist at the earliest opportunity.

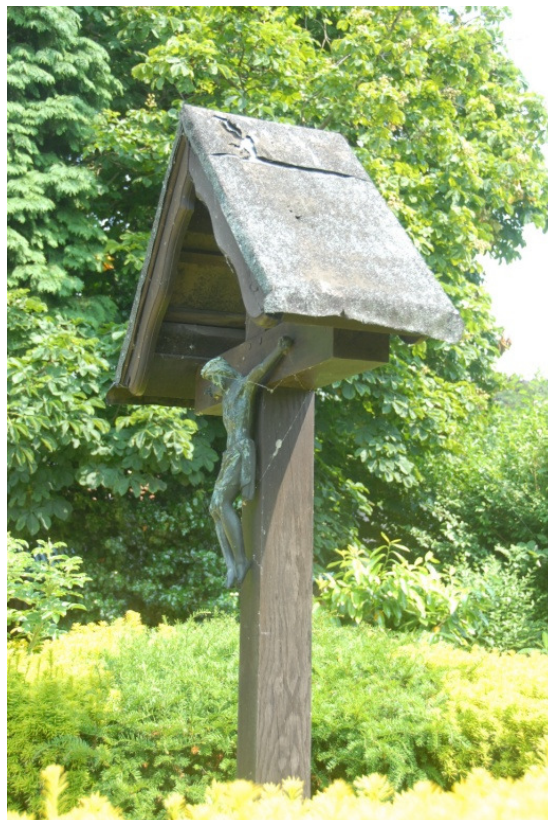
107 WW1 Monument: West Side Churchyard

At the front of the church (west side) is a small first world war memorial, consisting of a vertical timber crucifixion and octagonal stone base. A covering has been put over the small roof but this is now in need of replacement (see photograph 107).

| b) | Replace roof covering to WW1 monument in front f churchyard with non precious metal or natural slates. | £600 |

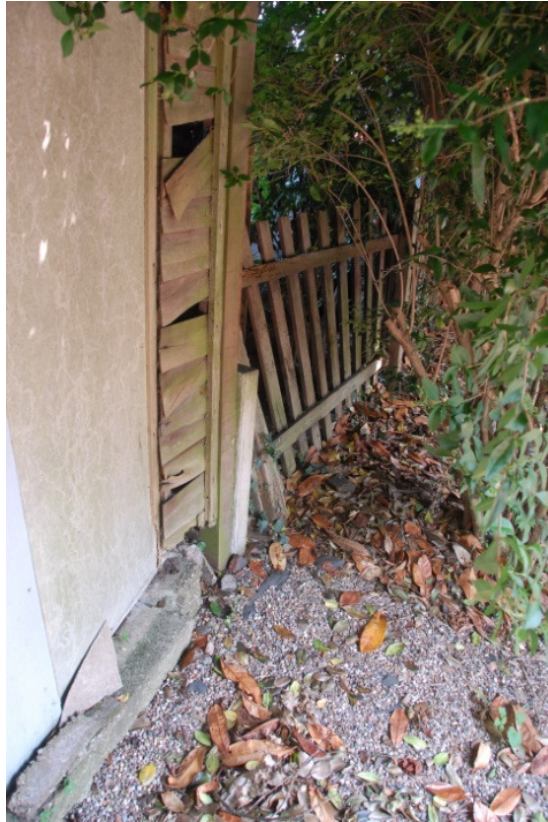
111 North Boundary and Broken Timber Fence

North Boundary: There is a timber fence broken in places (see photograph 111) and adjoining concrete garage.

| c) | Rebuild brick boundary walls and damaged timber fencing. | £15,000 to

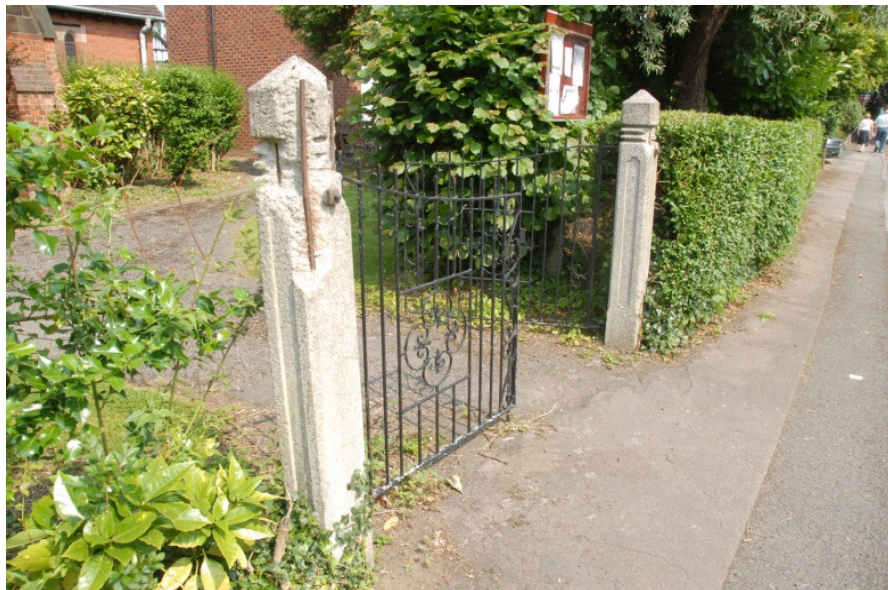
039 Rear Gates on Gordon Road (Note Corroded Concrete)

Box hedge with central metal gates. Both decorative concrete gate posts have failed and urgently need replacing/repairing. The metal gates need redecoration (see photograph 039).

| f) | Remove/repair concrete posts to rear entrance or replace with new type plus any foundations. | £900 |
